The 6th Regional Stakeholder Forum

Second Regional Information Sharing on Pak Lay Prior Consultation Process

Second Draft Technical Review on Navigation

Ms. Thi Thanh Yen Ton Nu, Navigation Operation Specialist, MRC Secretariat

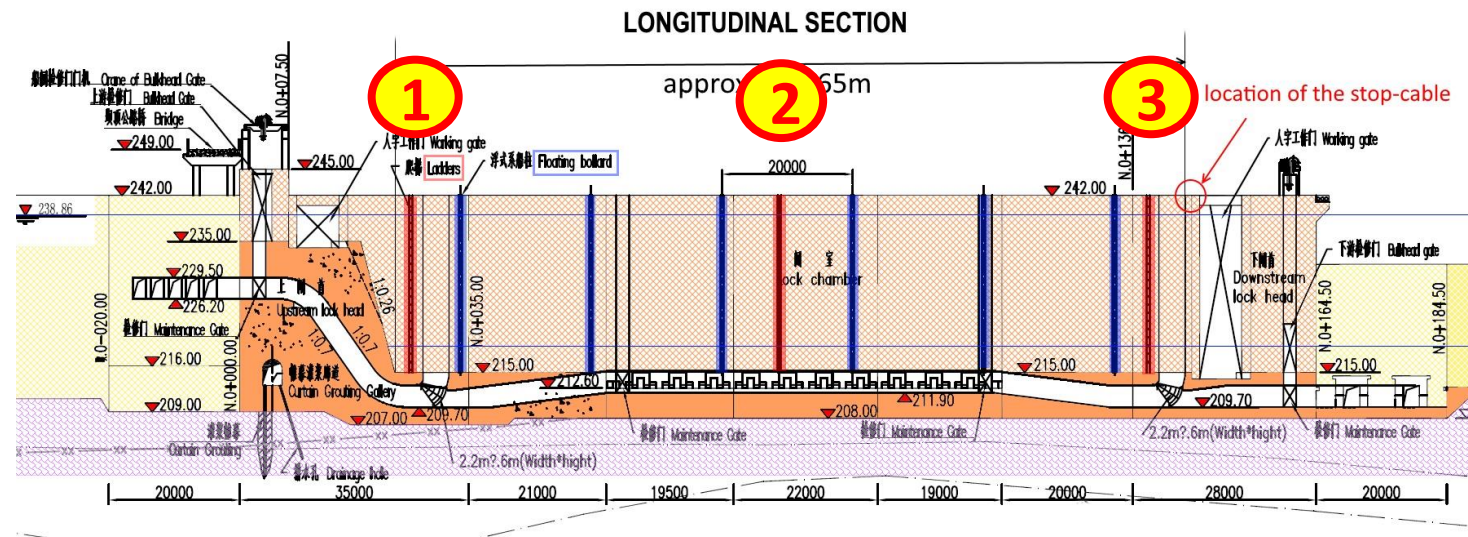
- Three ladders per lock chamber wall are not enough;
- “Six floating bollards are distributed along the lock chamber...”, hence totalling 12 over the entire lock chamber. In order to be consistent with Xayaburi: 2 x 5 floating bollards per lock chamber wall would be enough;

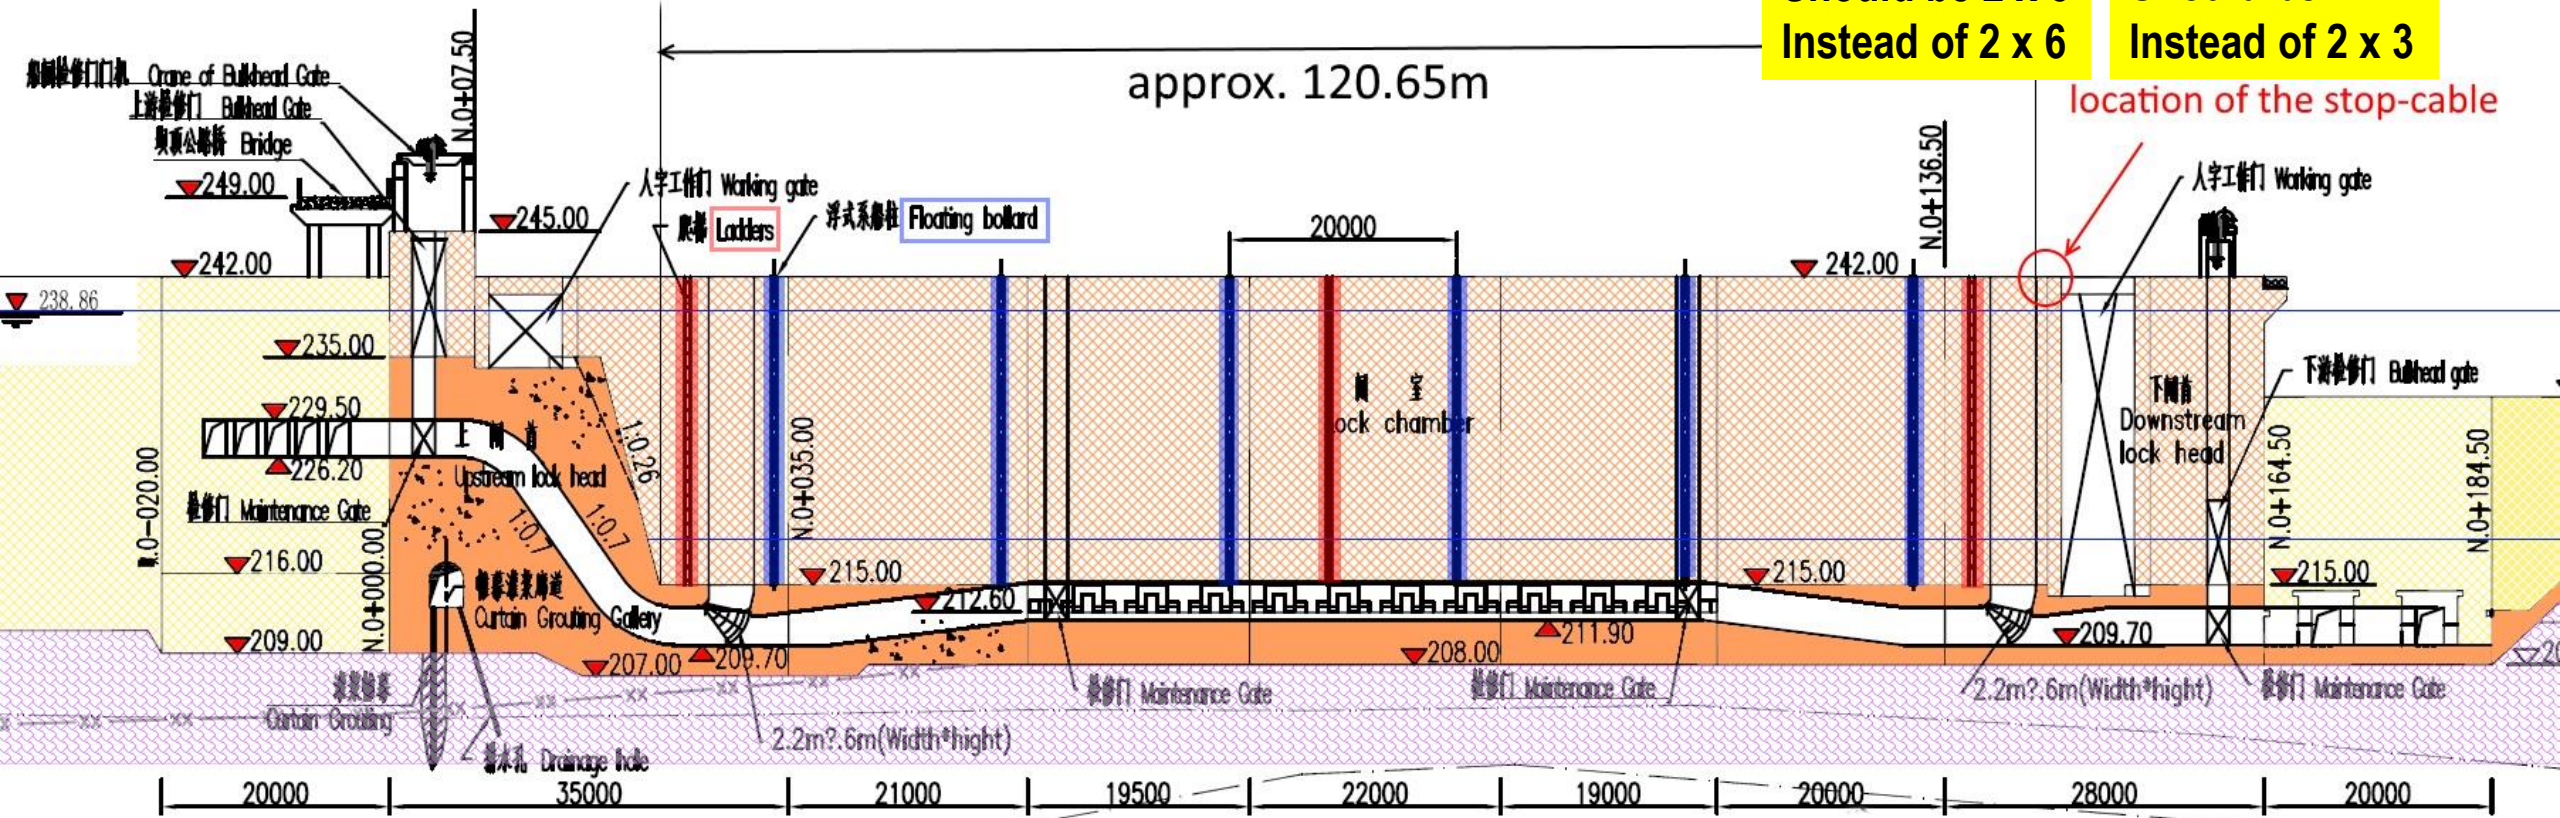
LONGITUDINAL SECTION

Floating Bollards **Ladders**

Should be 2 x 5
Instead of 2 x 6

Should be 2 x 4
Instead of 2 x 3

1. Increase the height of the bridge over the upper lock head and the rolling crane (minimum 10.00m);
2. Adapt ladders and floating bollard; provide enough space for stoppage cable;
3. Clearly define the area for the second ship lock including its approaches;
4. Improve (dredge?) and provide Nav aids to the upstream navigation channel which has to cross in front of the powerhouse and spillway;

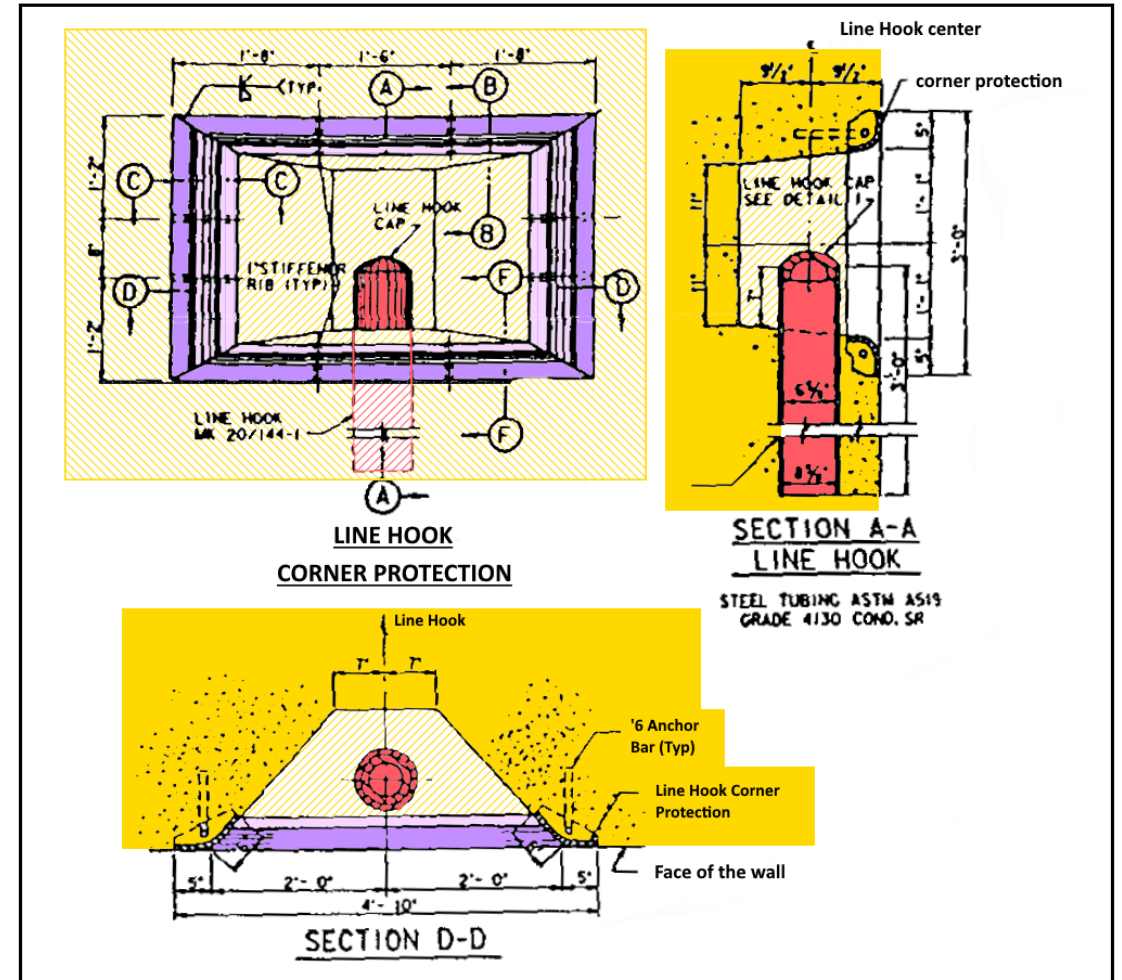
- There should be line hooks in the lock chamber and the guidance walls at various levels, adjacent to the ladders;
- At least one additional ladder in the upper and lower guidance walls outside the chamber are recommended.

Line hooks at various levels inside the lock chamber

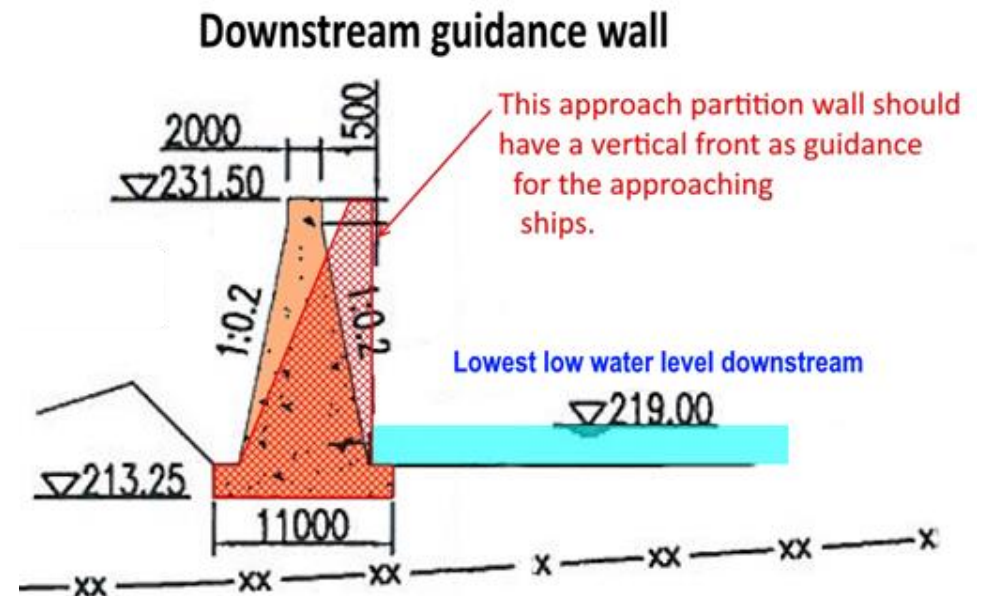
- The ship lock is situated at the right river bank, which is a shallow area of the river. The current navigation channel is on left
- The area for the second ship lock and its axis has not been clearly defined and is not shown on the drawing
- No clear plan or drawing indicating the actual and future the ship-lock
- The downstream guidance wall doesn't have a vertical front as is the case with the upstream guidance wall

5. Reconsider the locations of the 5 dolphins up- and downstream that will hinder the entrance to the future second ship lock;
6. The downstream guidance wall should have a vertical front;
7. Redesign the downstream navigation channel including additional excavation works to accommodate future second shiplock access;
8. Road connections to all parts of the ship lock, also to the downstream lock head.

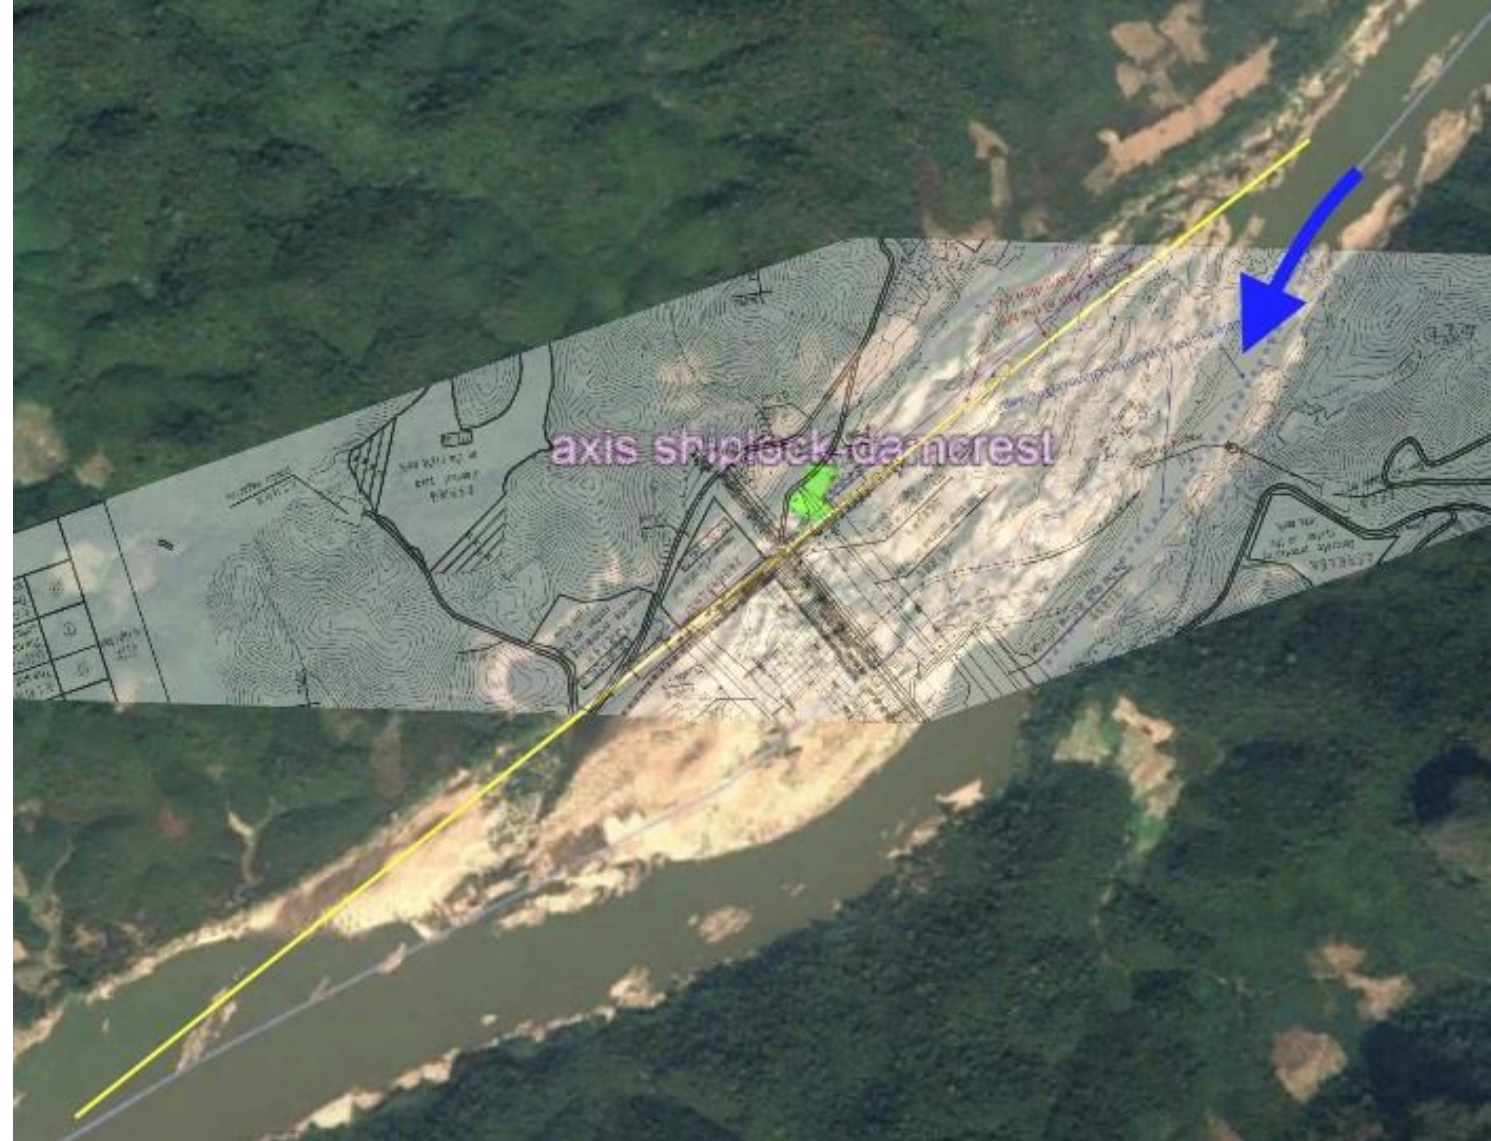
Developer's situation plan superposed on the Google Earth picture, showing the new navigation channel will be over a very substantial length in shallow area (dry rocky land during low water season)

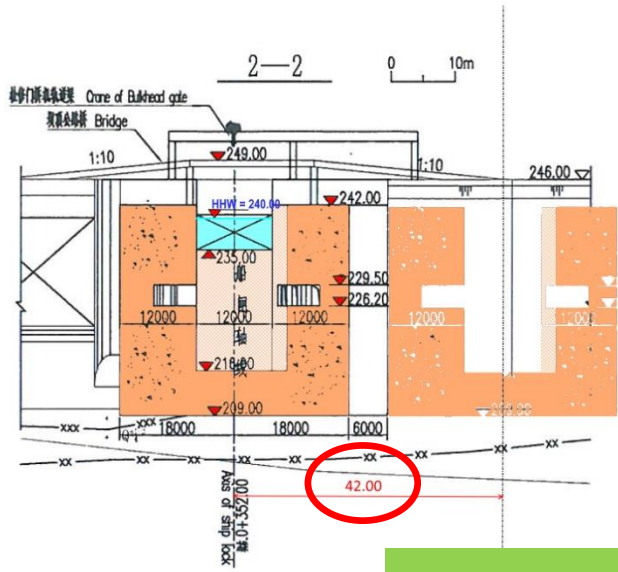
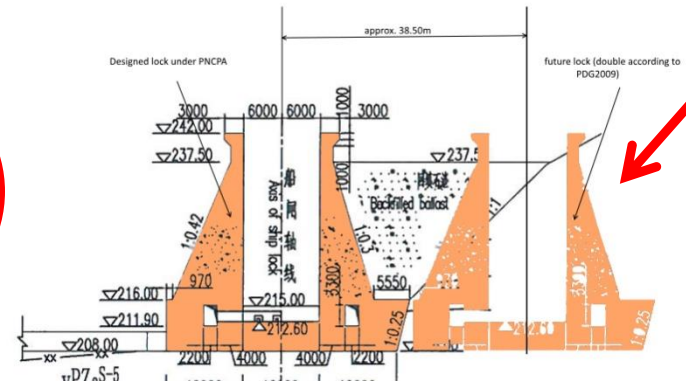
SECOND SHIP LOCK ALIGNMENT AT RIGHT BANK

Second lock!

Future lock (PDG2009)

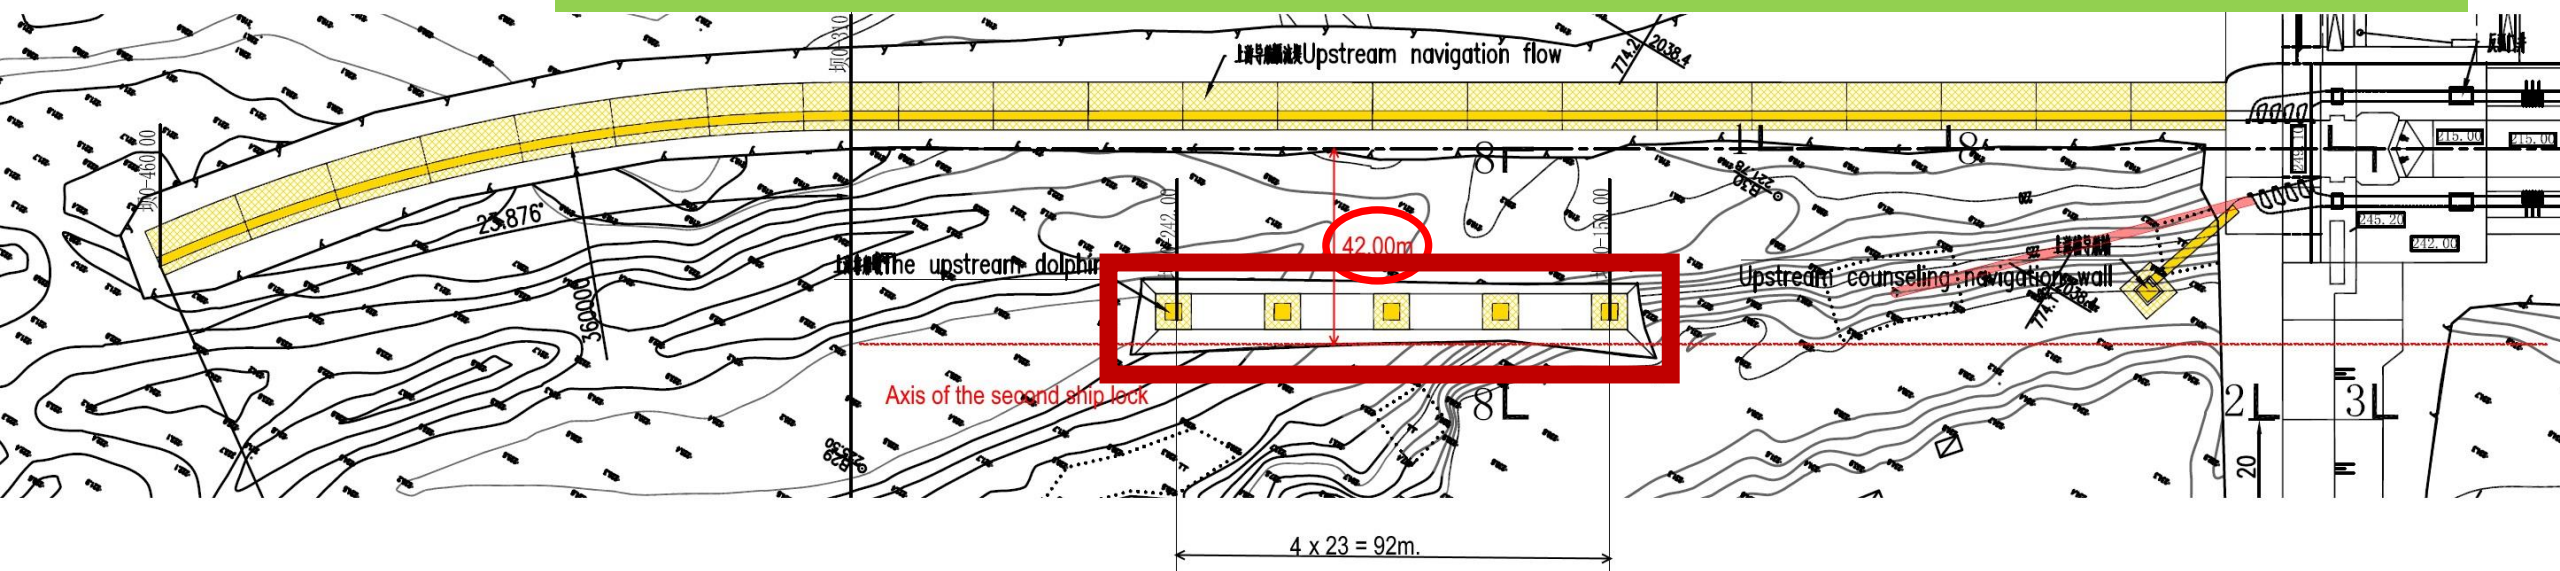
UPSTREAM APPROACH CHANNEL

OBSTRUCTING THE APPROACH TO THE FUTURE SECOND SHIP LOCK!!!

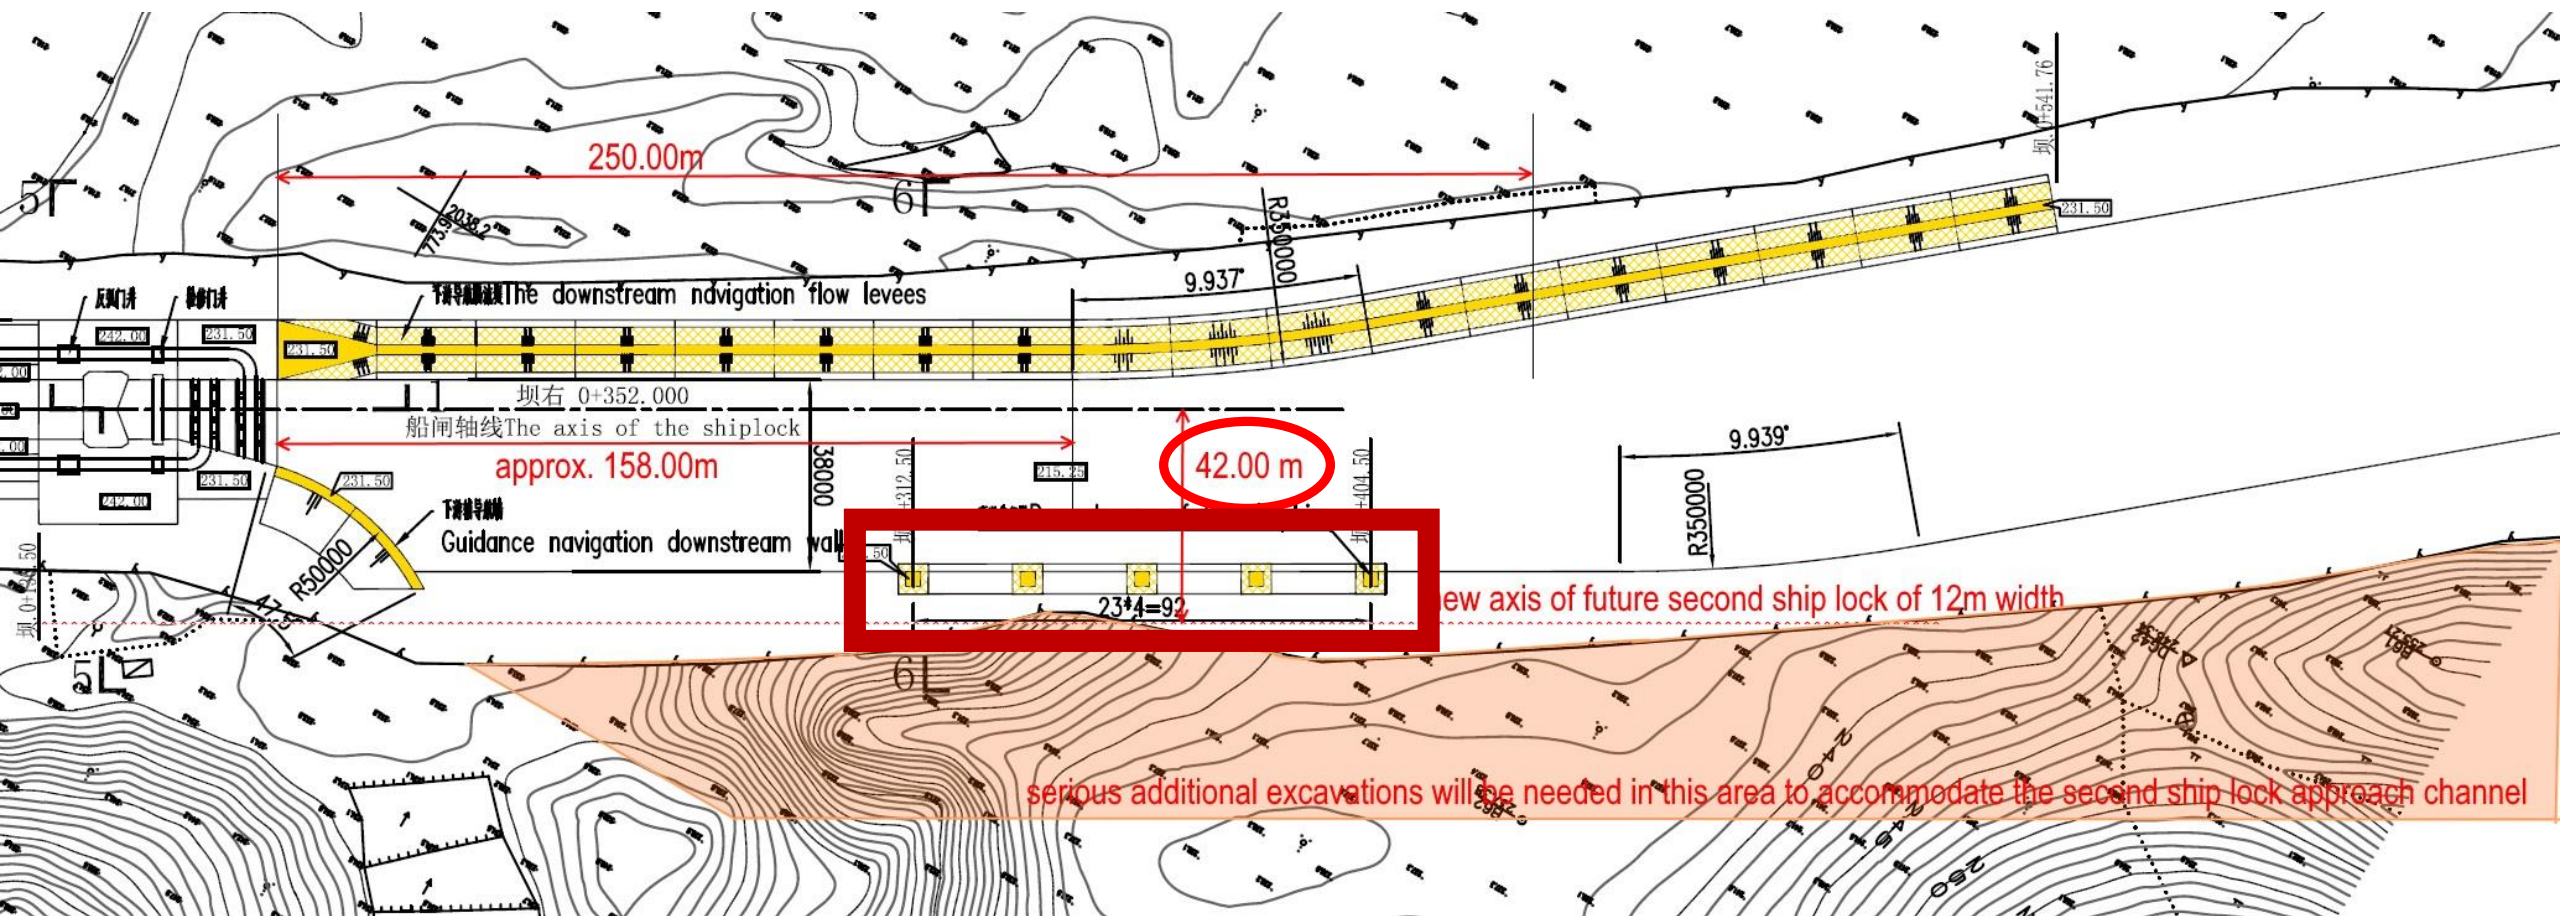
extra excavations to improve nautical access

OBSTRUCTING THE APPROACH TO THE FUTURE SECOND SHIP LOCK!!!
